**EMERGENCY STRUCTURAL ASSESSMENT
OF
EARTHQUAKE DAMAGE TO KAILUA - KONA WHARF
LOCATED AT
KAILUA - KONA, HAWAII

PREPARED FOR
THE STATE OF HAWAII
DEPARTMENT OF LAND AND NATURAL RESOURCES
DIVISION OF BOATING AND OCEAN RECREATION
HONOLULU, HAWAII 96813**

**ARNOLD T. OKUBO & ASSOCIATES, INC.
94-529 UKEE STREET, SUITE 107
WAIPAHU, HAWAII 96797**

NOVEMBER 2006

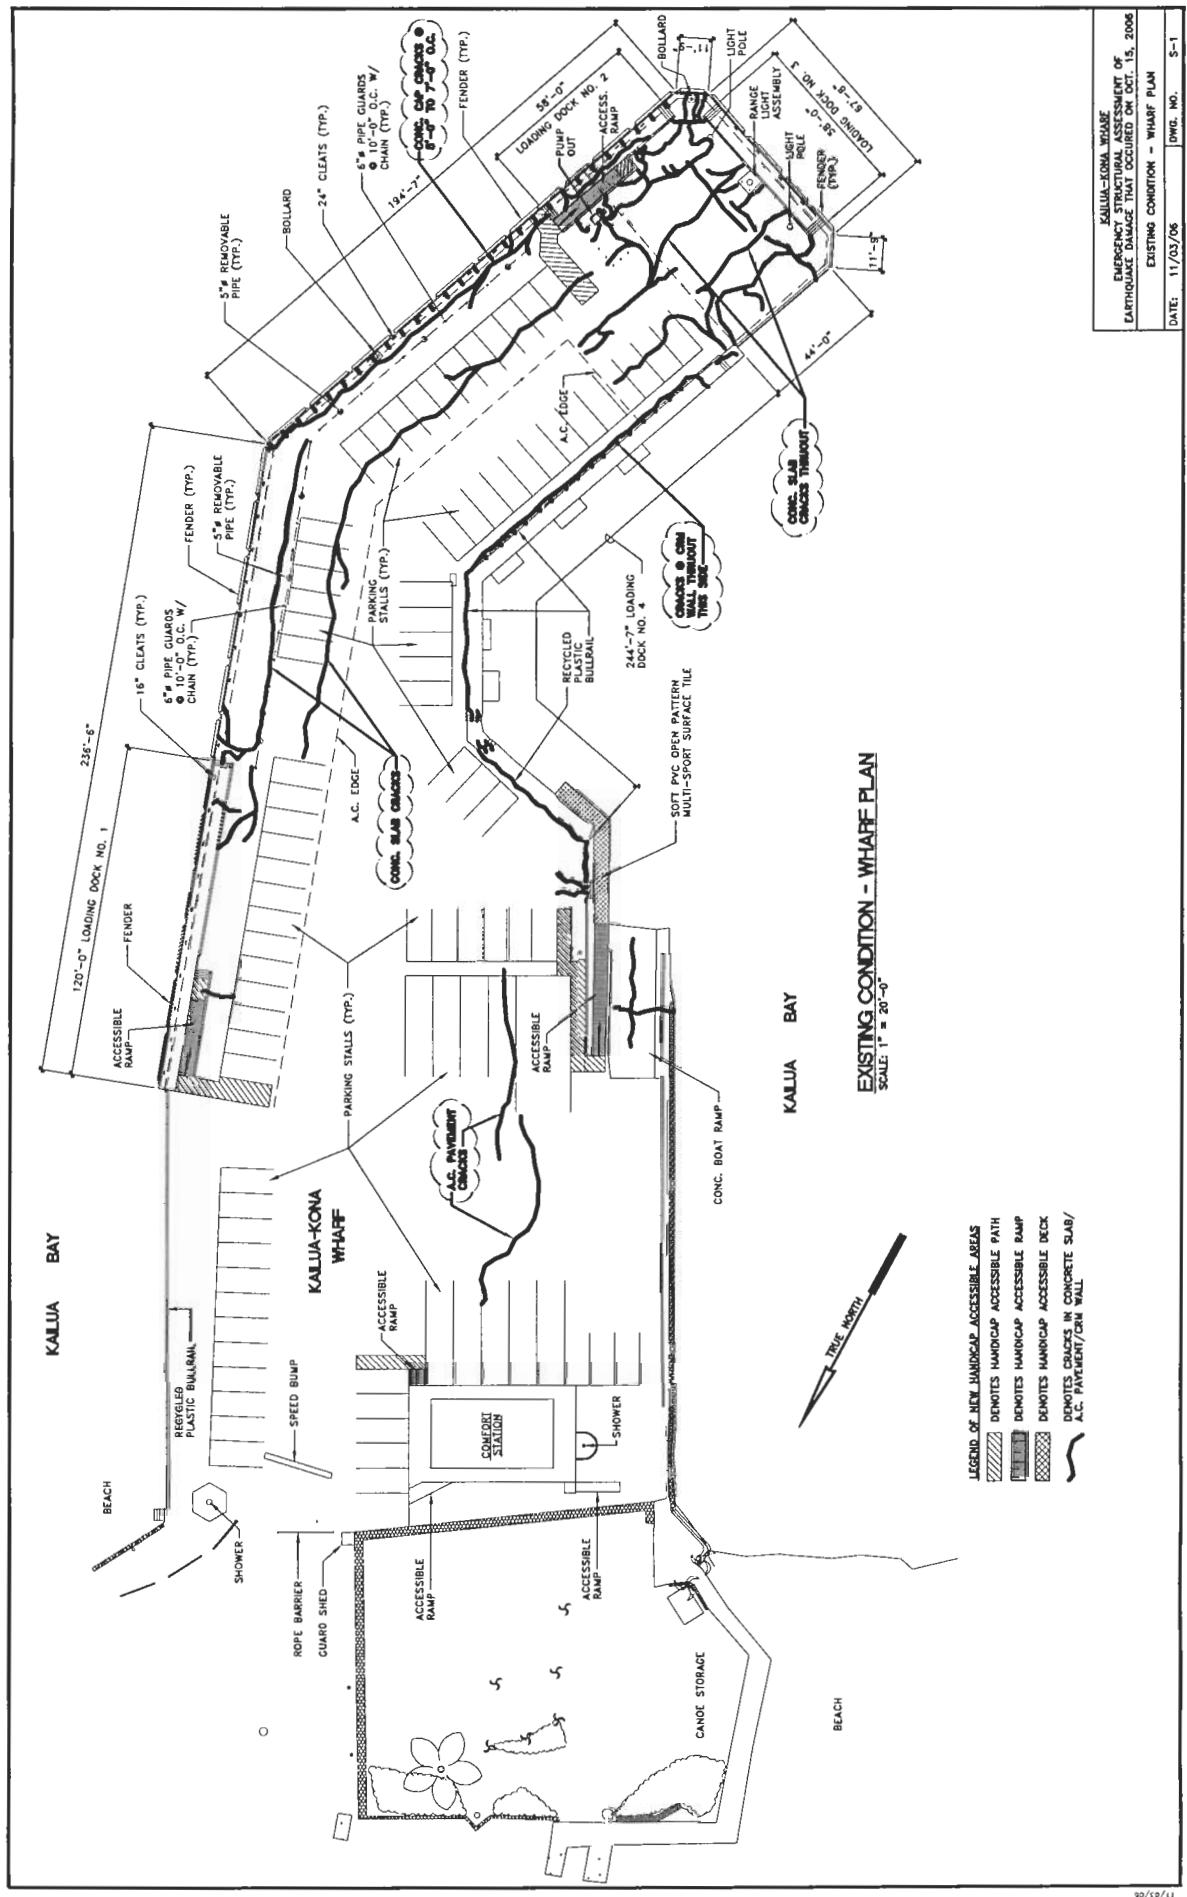
DENOTES HANDICAP ACCESSIBLE PATH
	DENOTES HANDICAP ACCESSIBLE RAMPS
	DENOTES HANDICAP ACCESSIBLE DECKS
	DENOTES CRACKS IN CONCRETE SLABS A.C. PAYMENT/CRA WALL

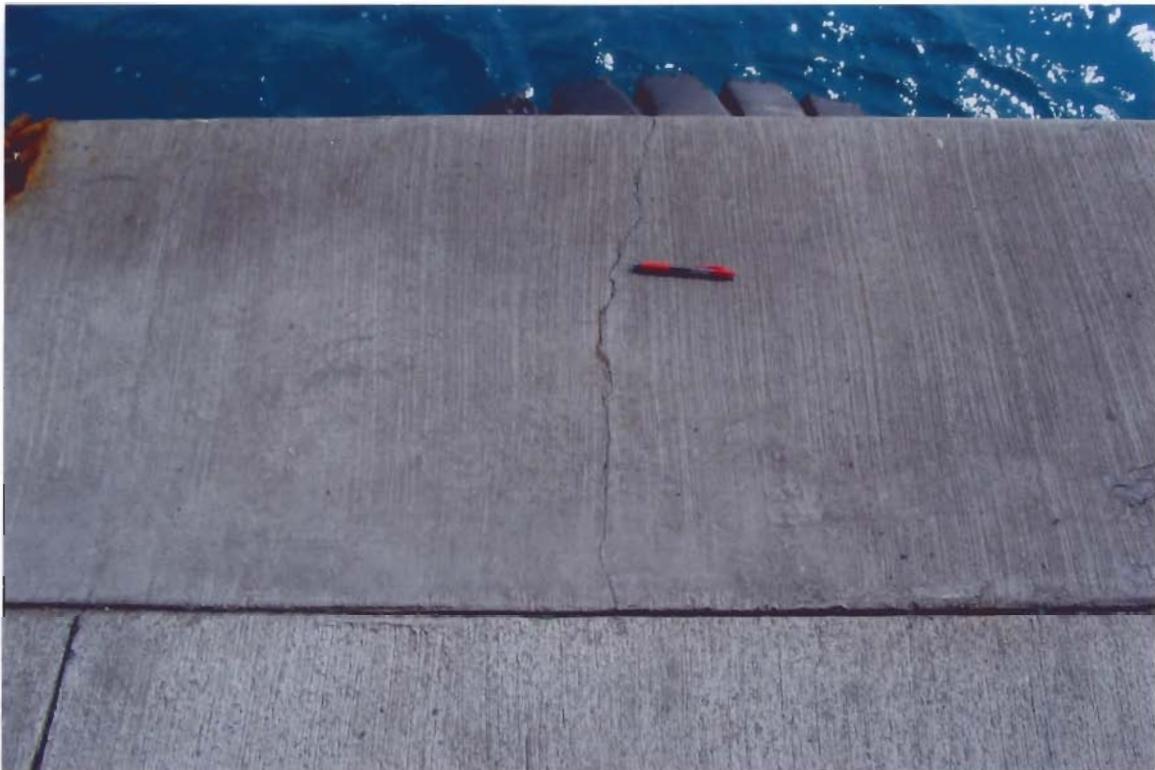
13

South East Side -
Typical cracks at pile caps

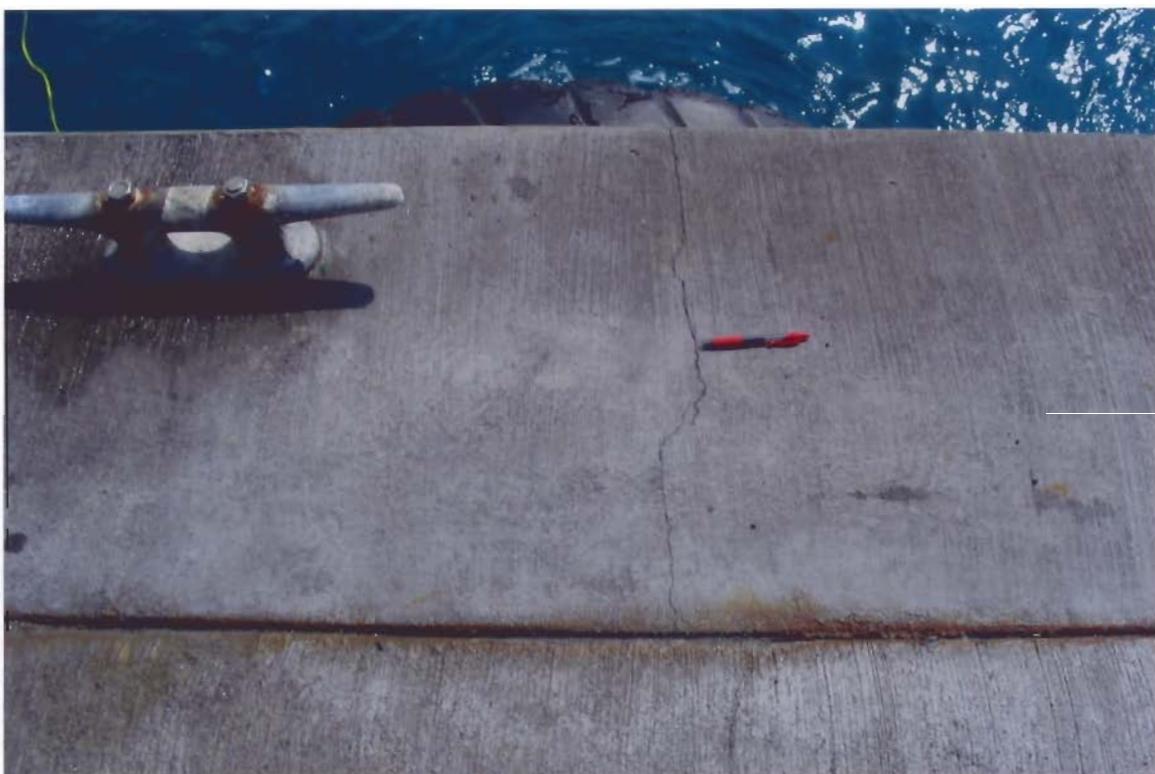
14

South East Side -
Typical cracks at pile caps

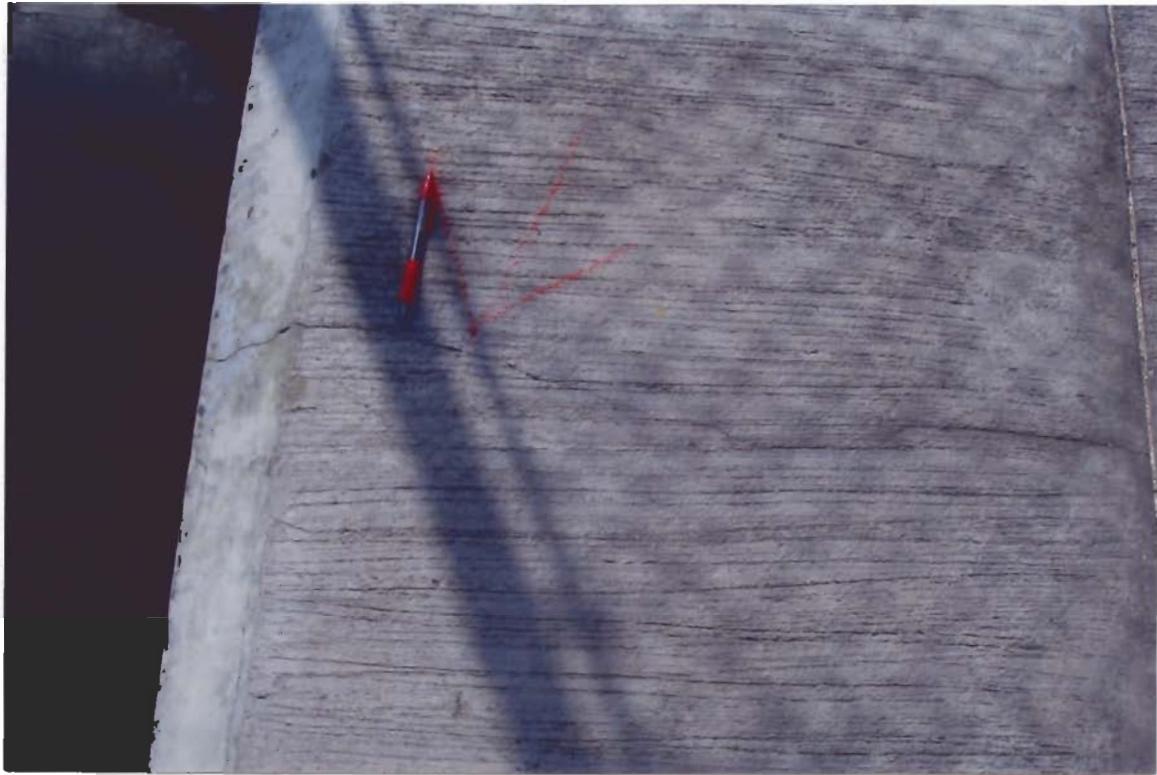
15

South East Side -
Typical cracks at pile caps

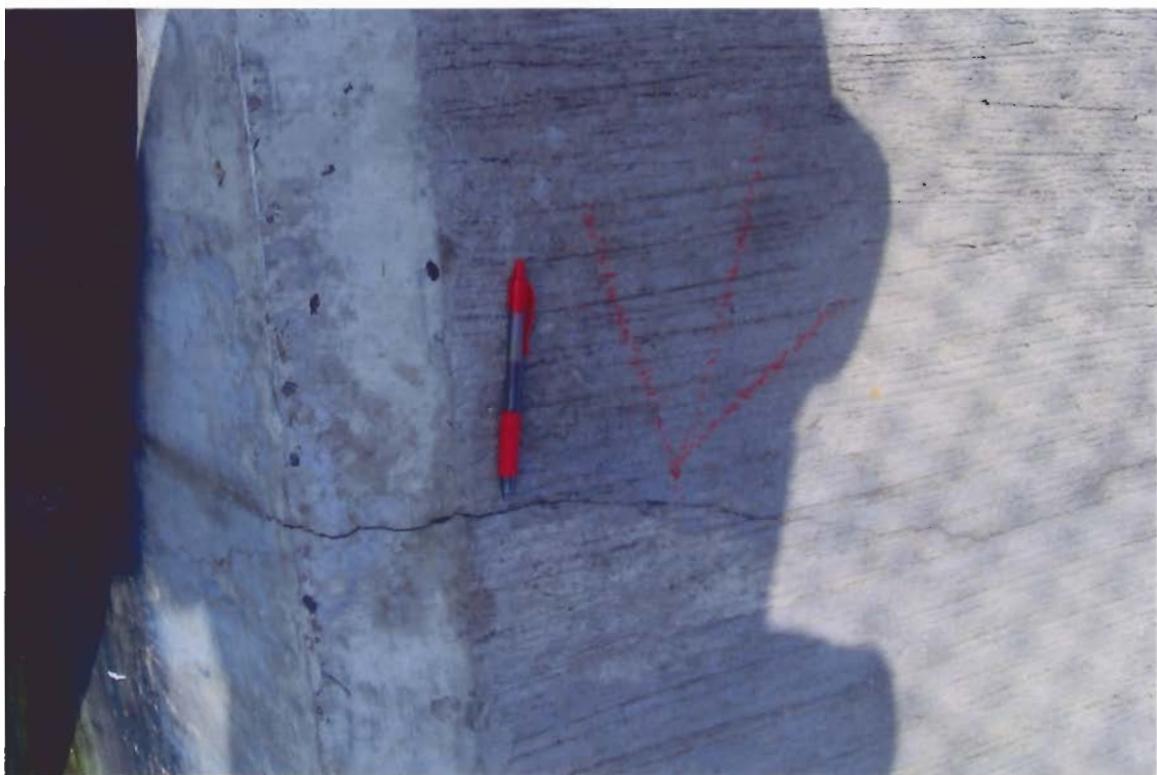
16

South East Side -
Typical cracks at pile caps

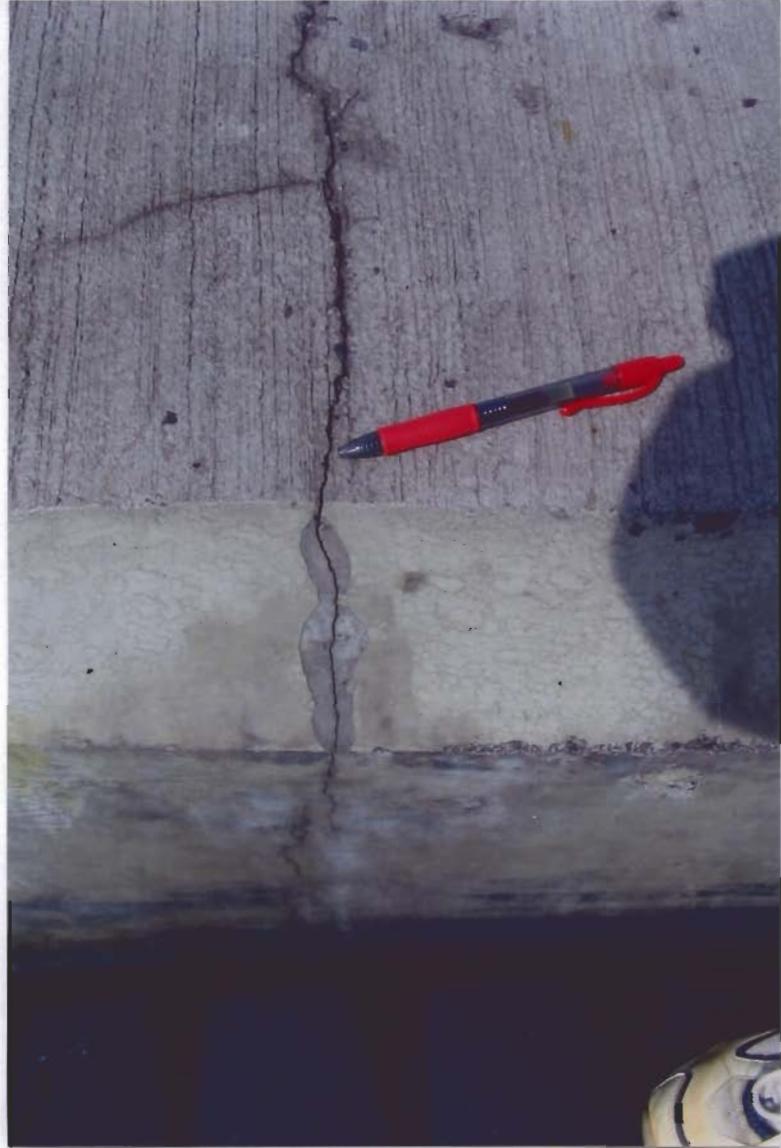
17

South East Side -
Typical cracks at pile caps

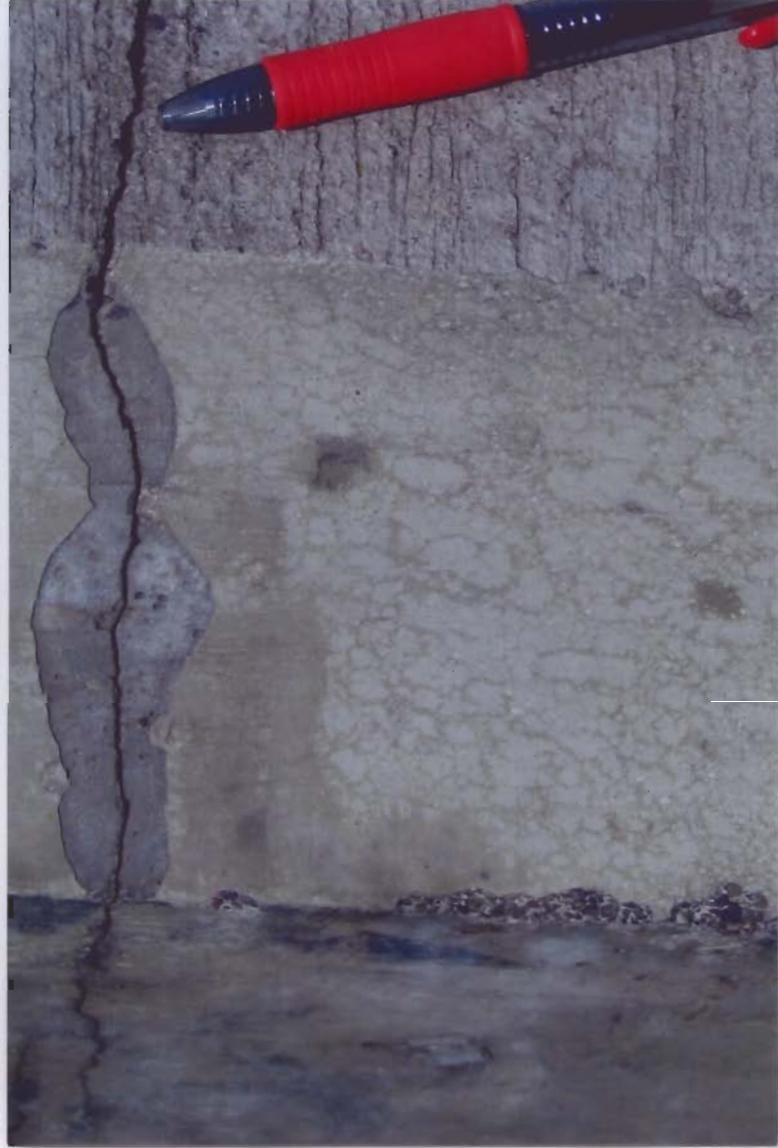
18

Typical cracks at
pile caps

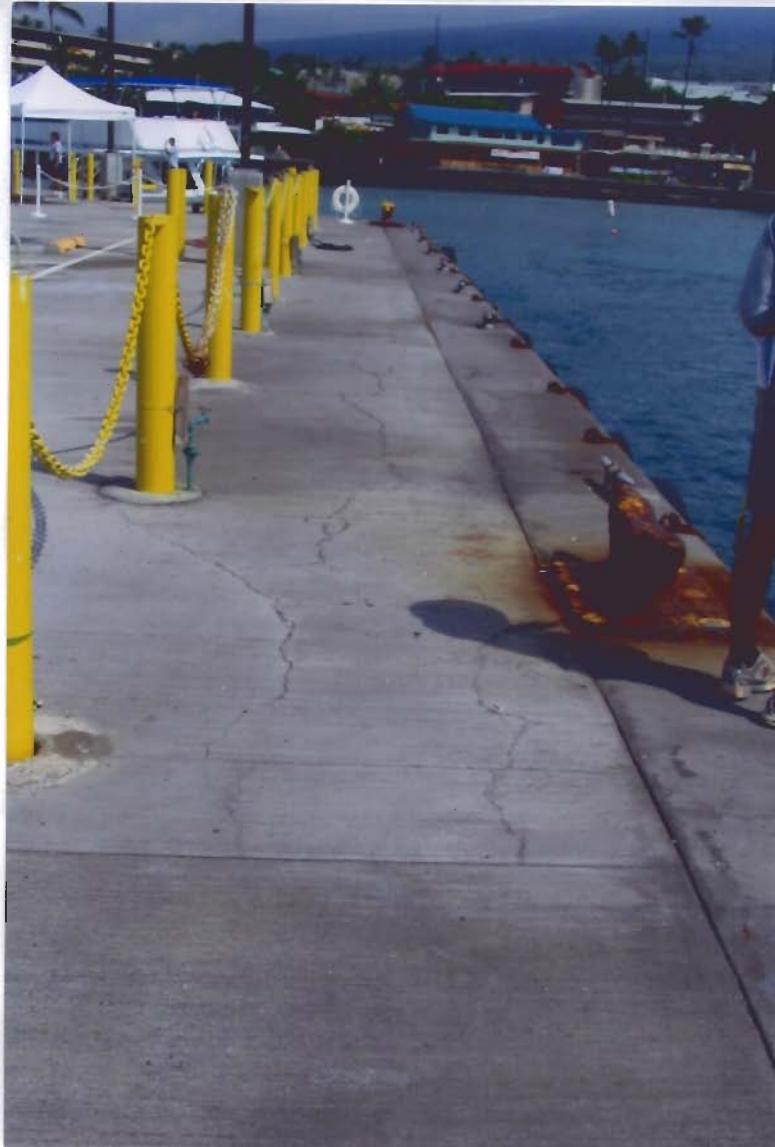
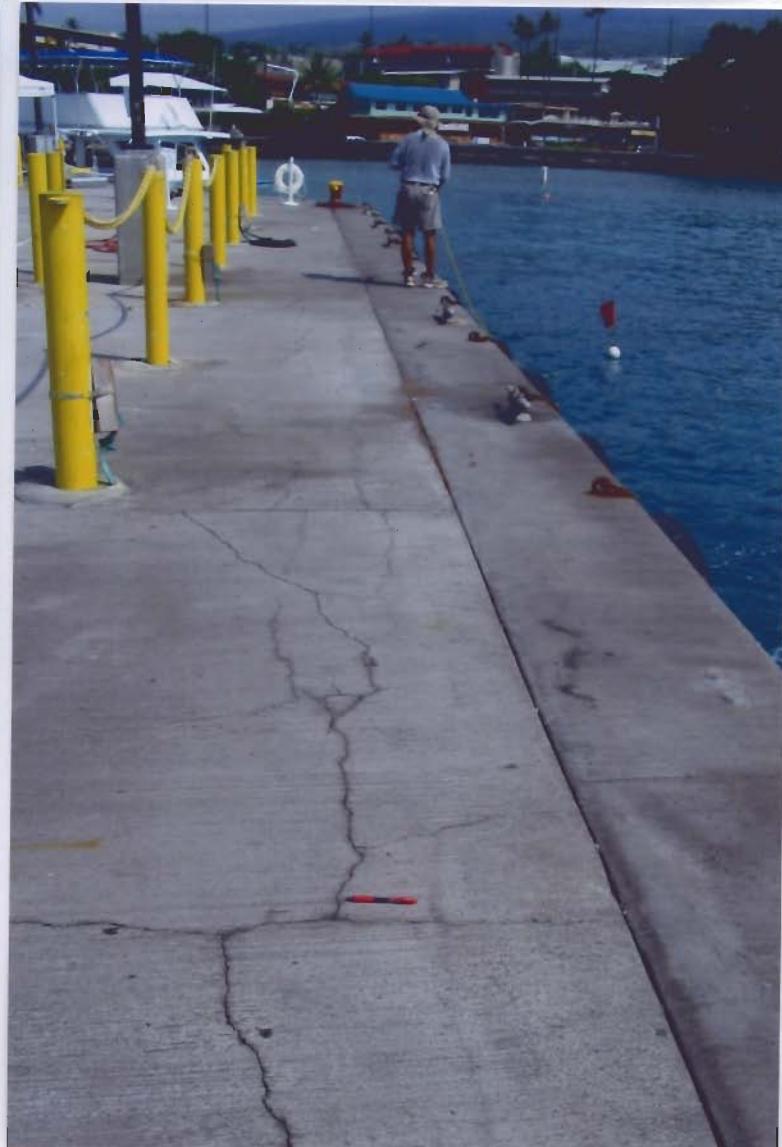
19

East Side - Typical cracks on deck slab throughout

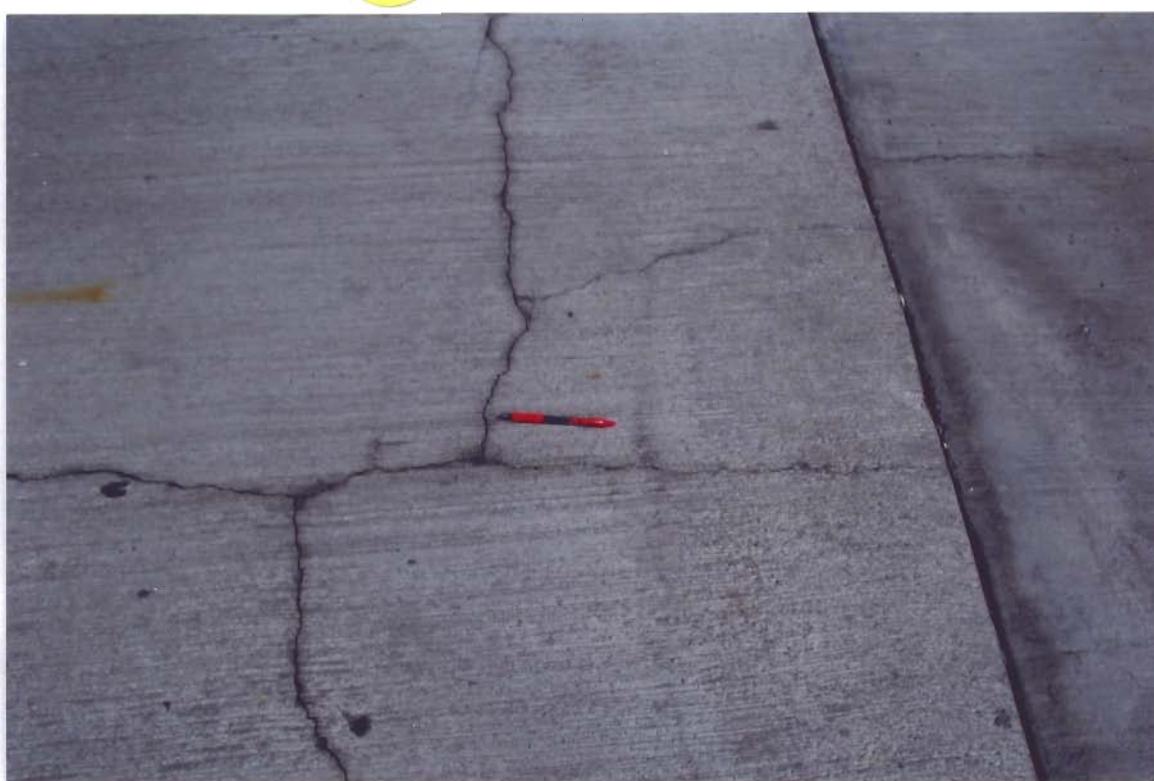
20

Close-up view of
cracks on deck
slab

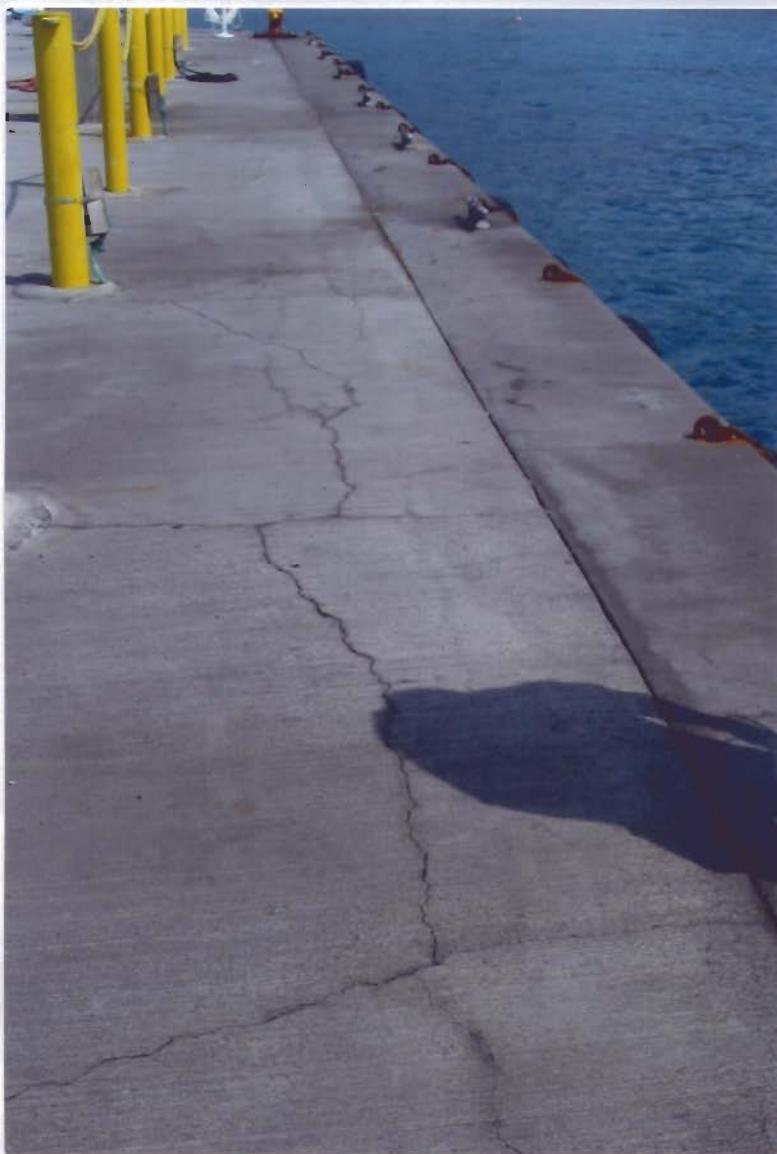
21 East Side - Typical cracks on deck slab throughout

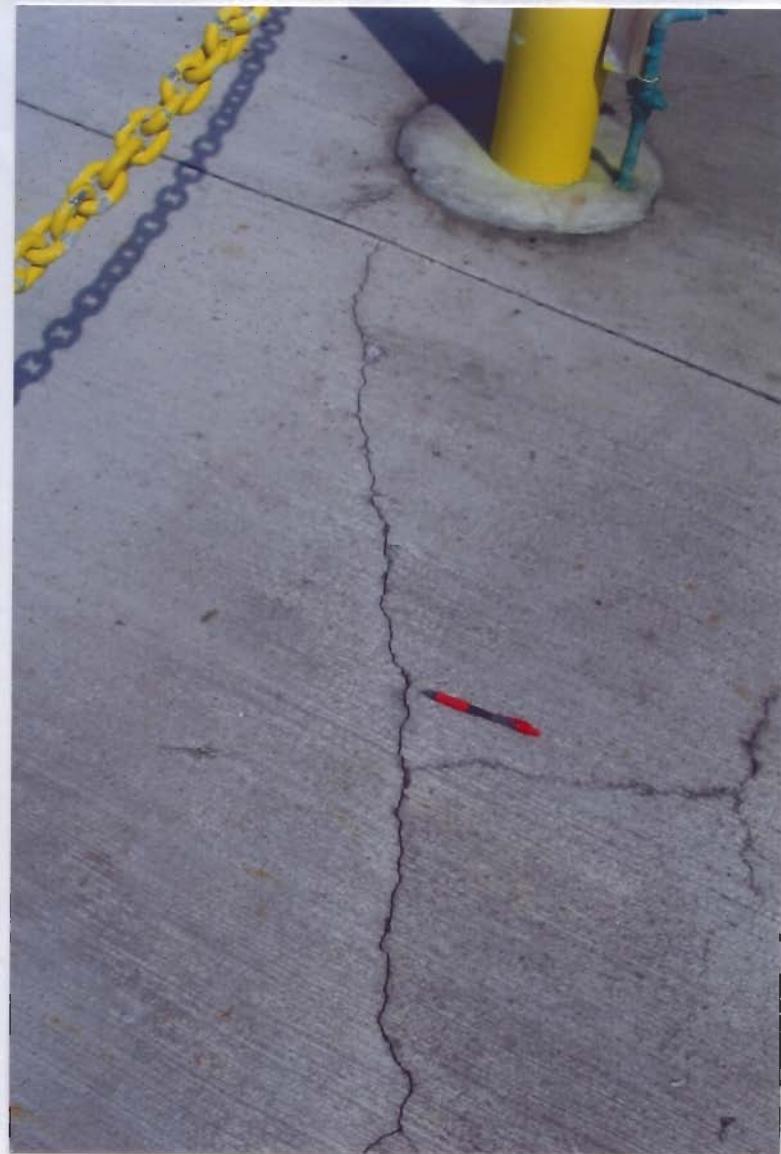
22 Close-up view of crack deck slab

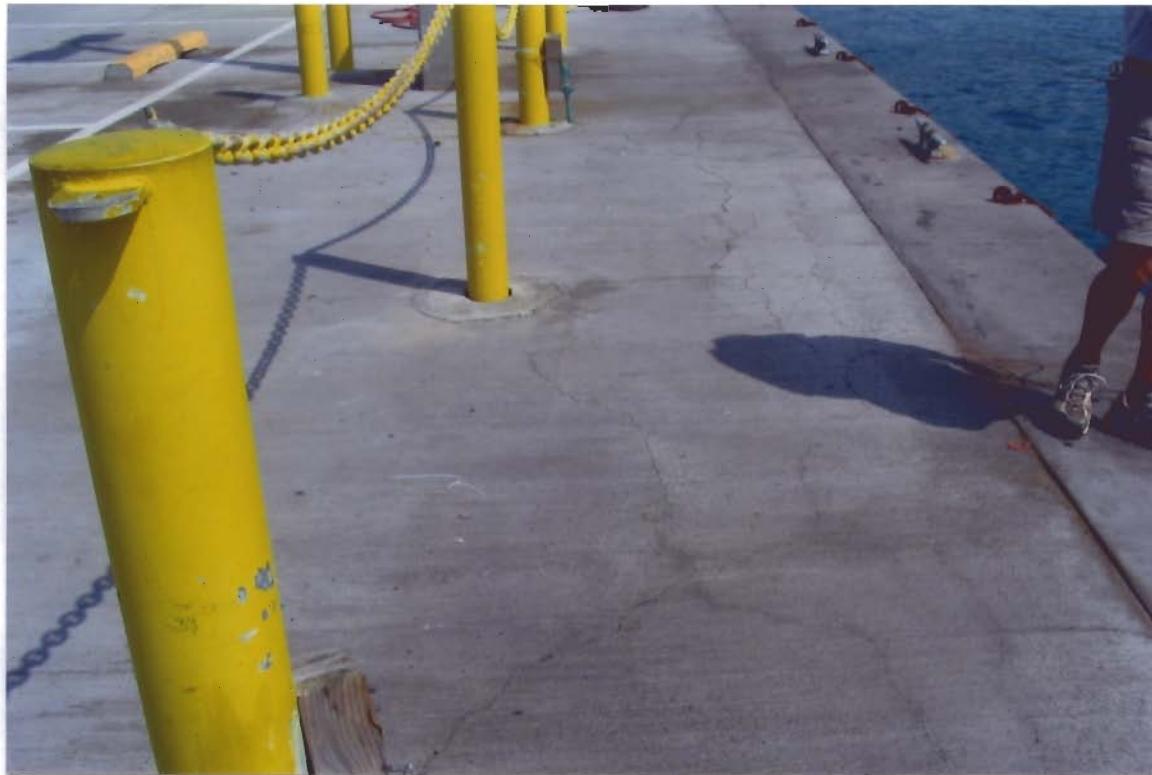
23 East Side - Cracks on deck slab throughout

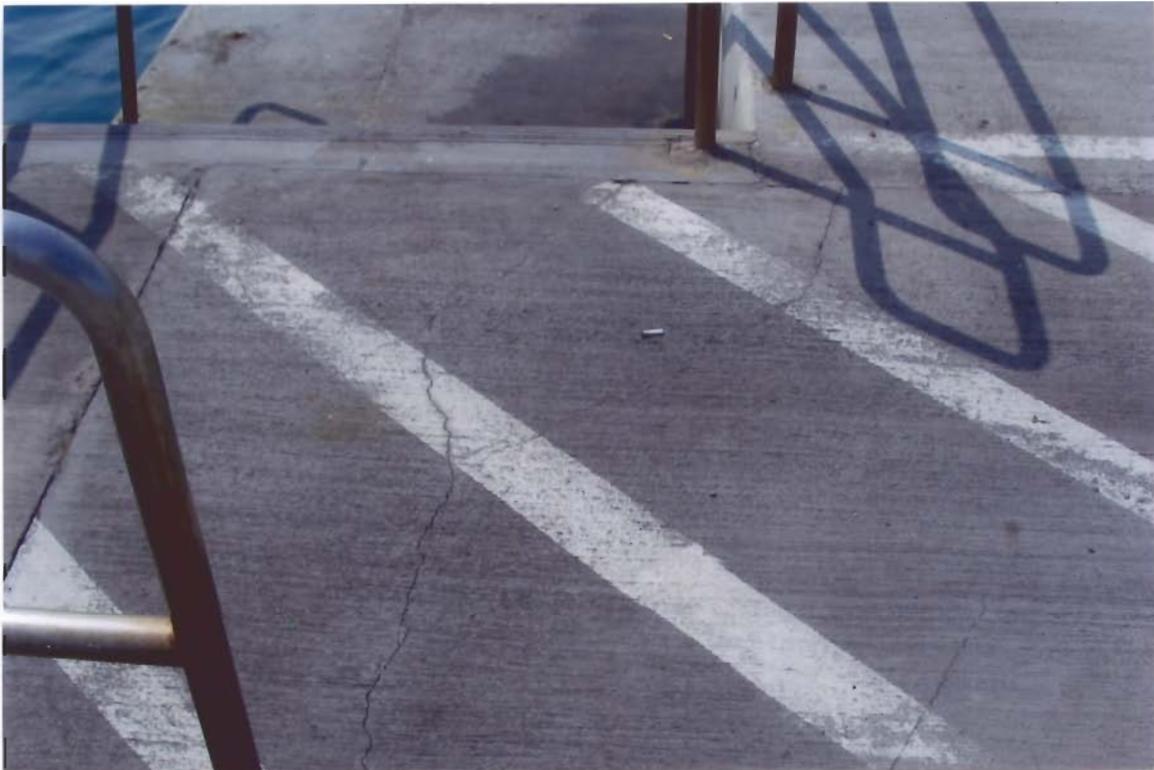
24

Cracks on slab landing at
Loading Dock No. 2

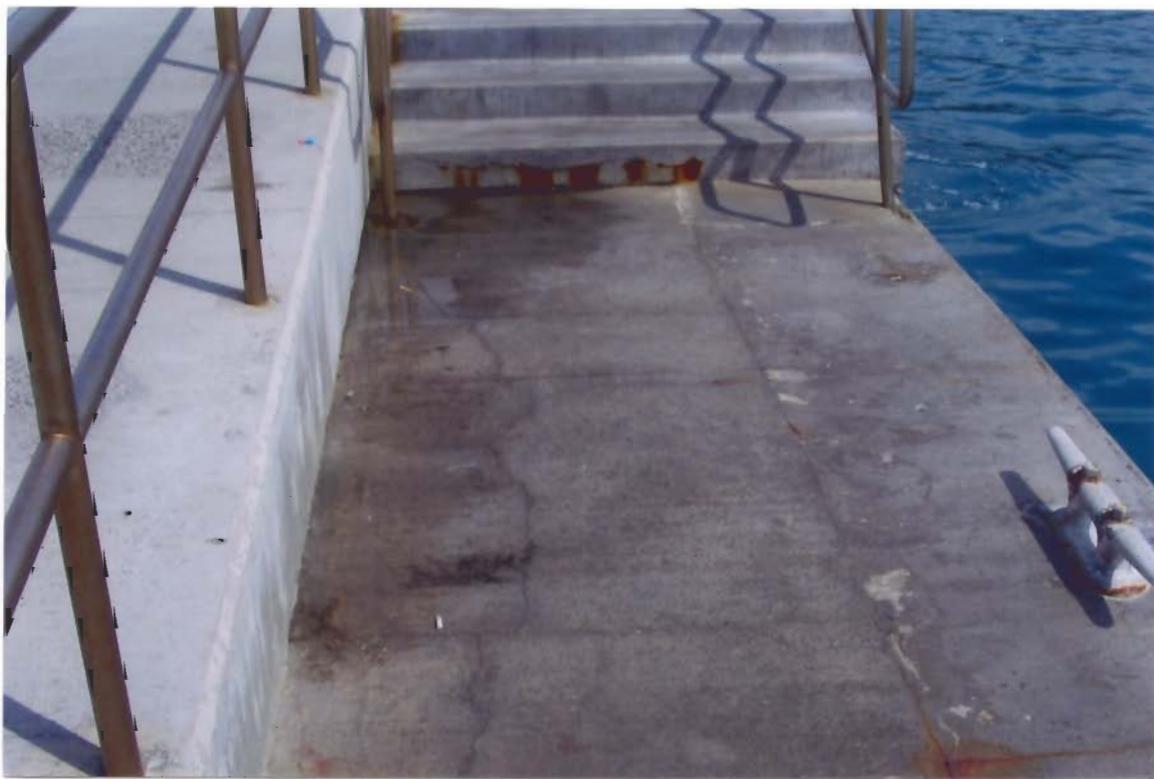
25

Loading Dock No. 2 -
Cracks on deck slab area

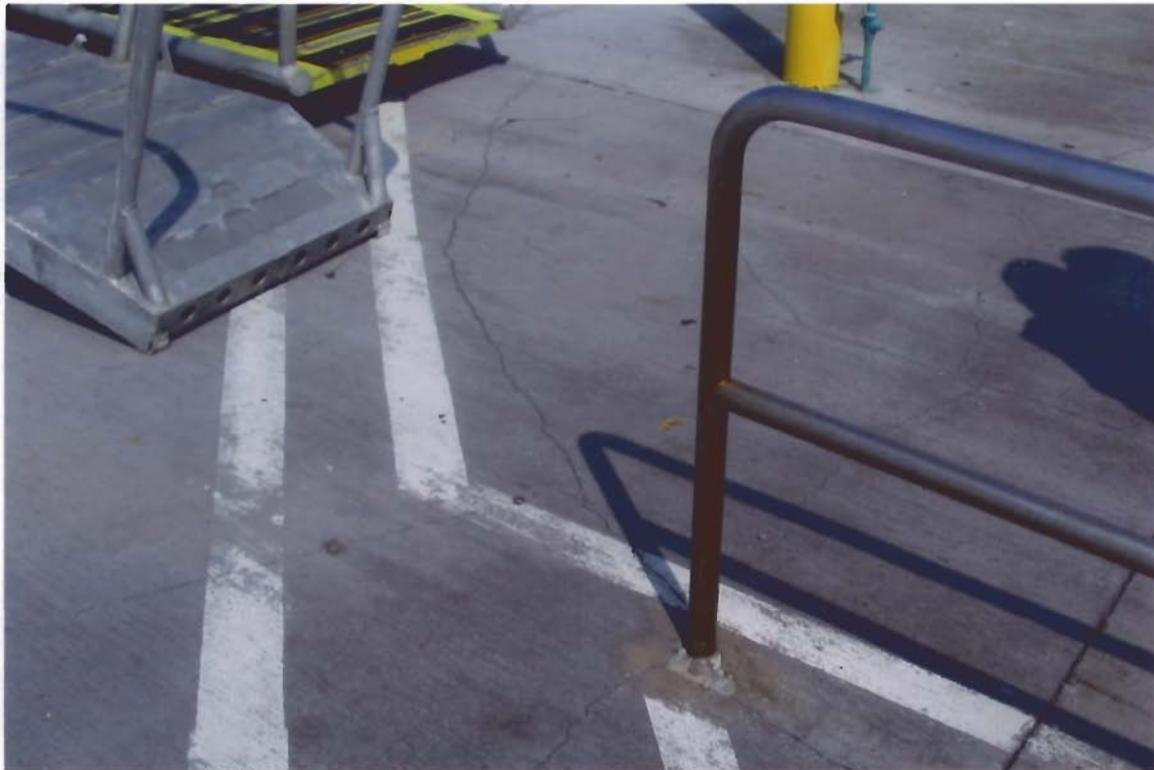
26

Loading Dock No. 2 - Typical
slab cracks at landing throughout

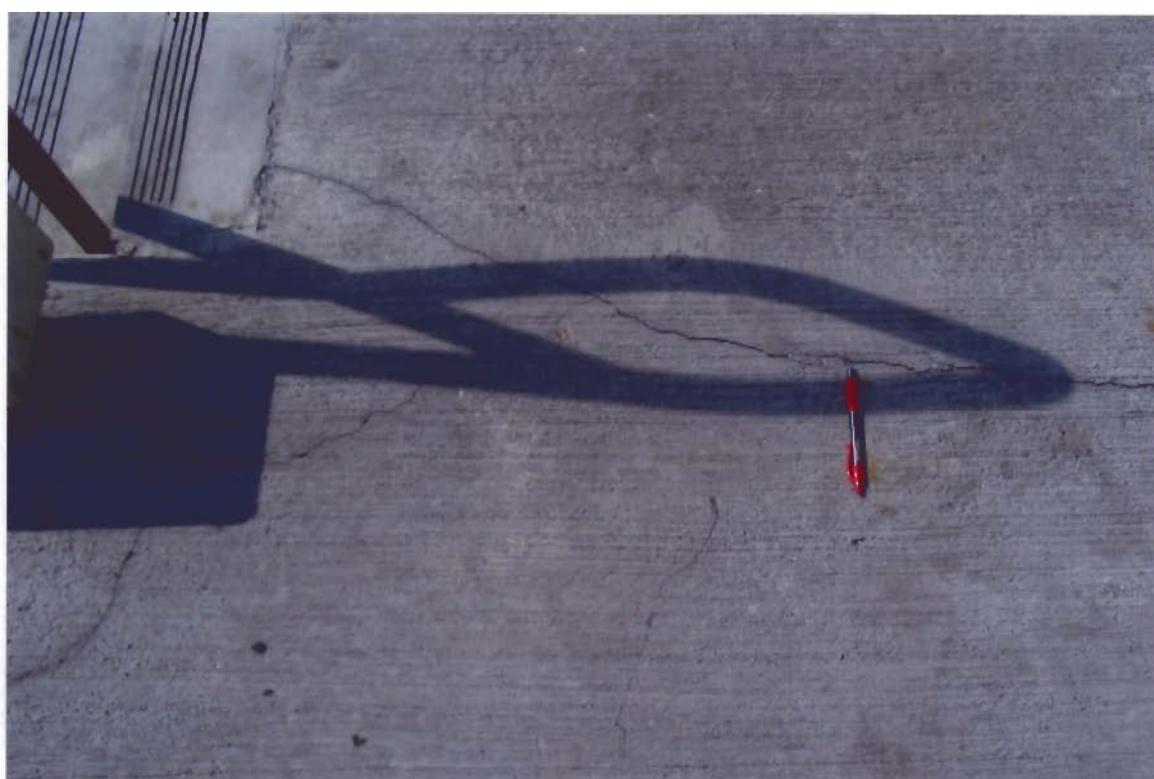
27

Loading Dock No. 2 -
Typical slab cracks at landing

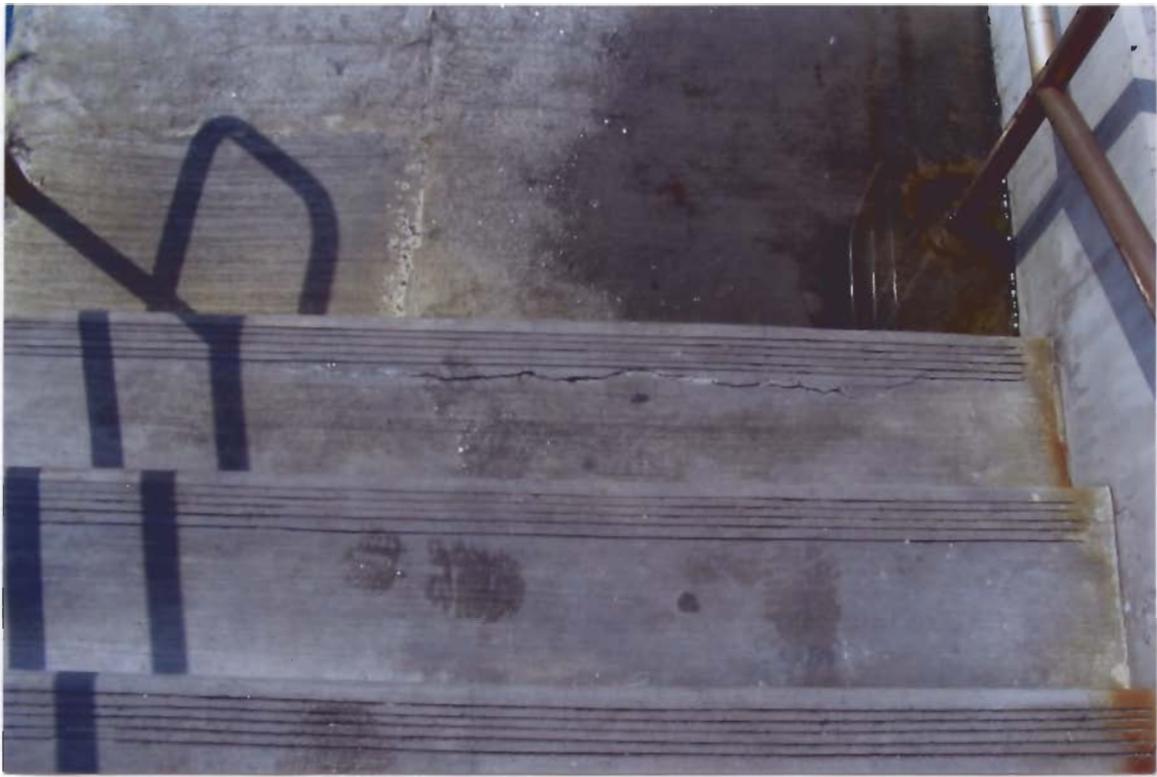
28

Stairway at Loading Dock No. 2 -
Cracks at stair threads

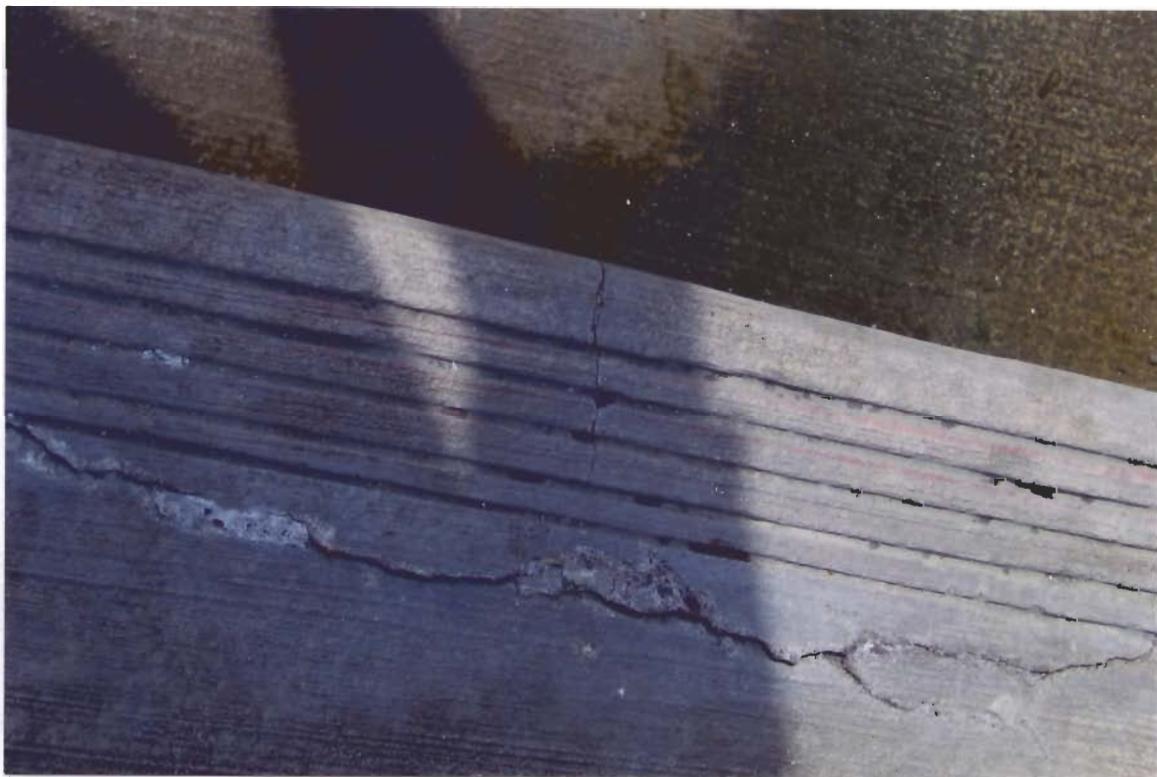
29

Stairway at Loading Dock No. 2 -
Cracks at stair threads

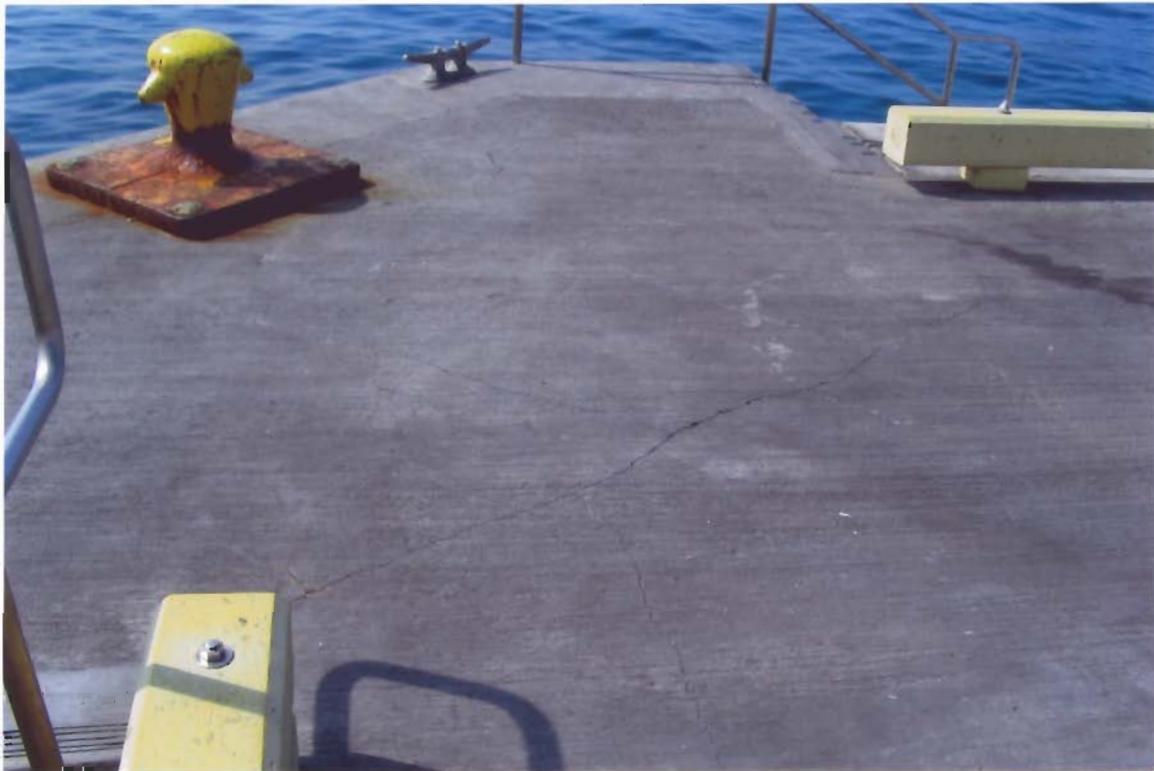
30

South End - Cracks on slab
throughout deck area

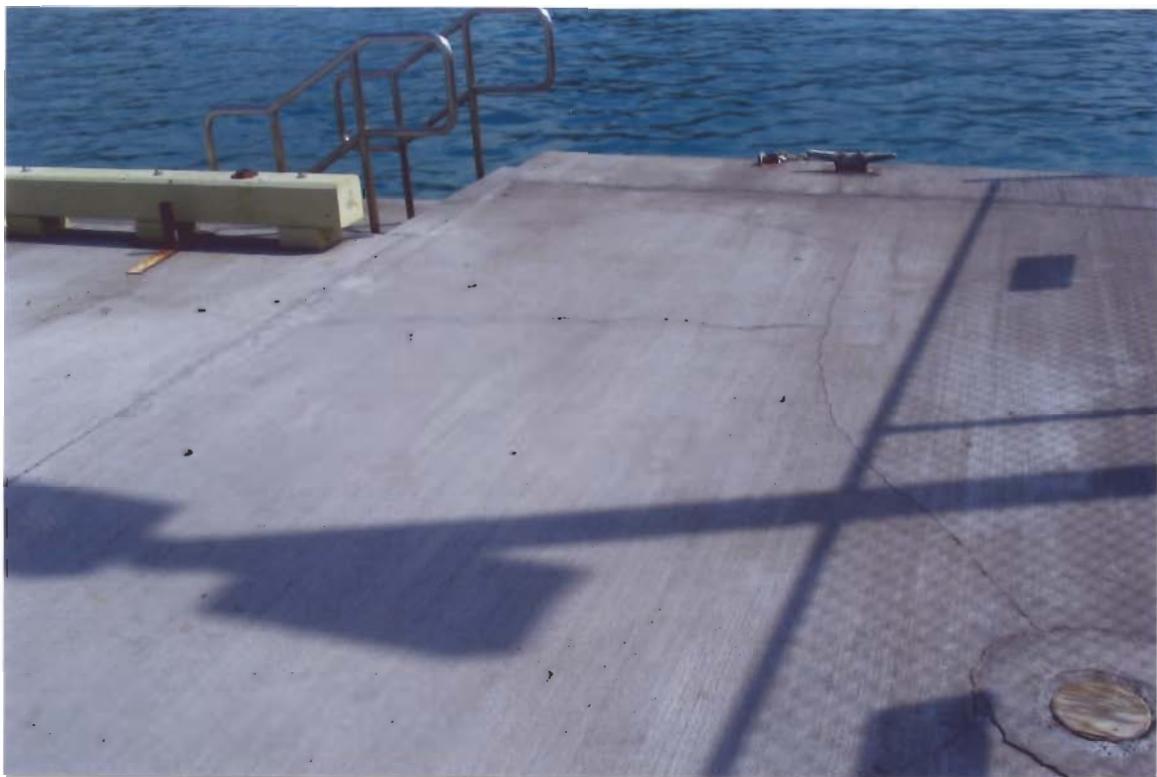
31

South End - Cracks on slab
throughout deck area

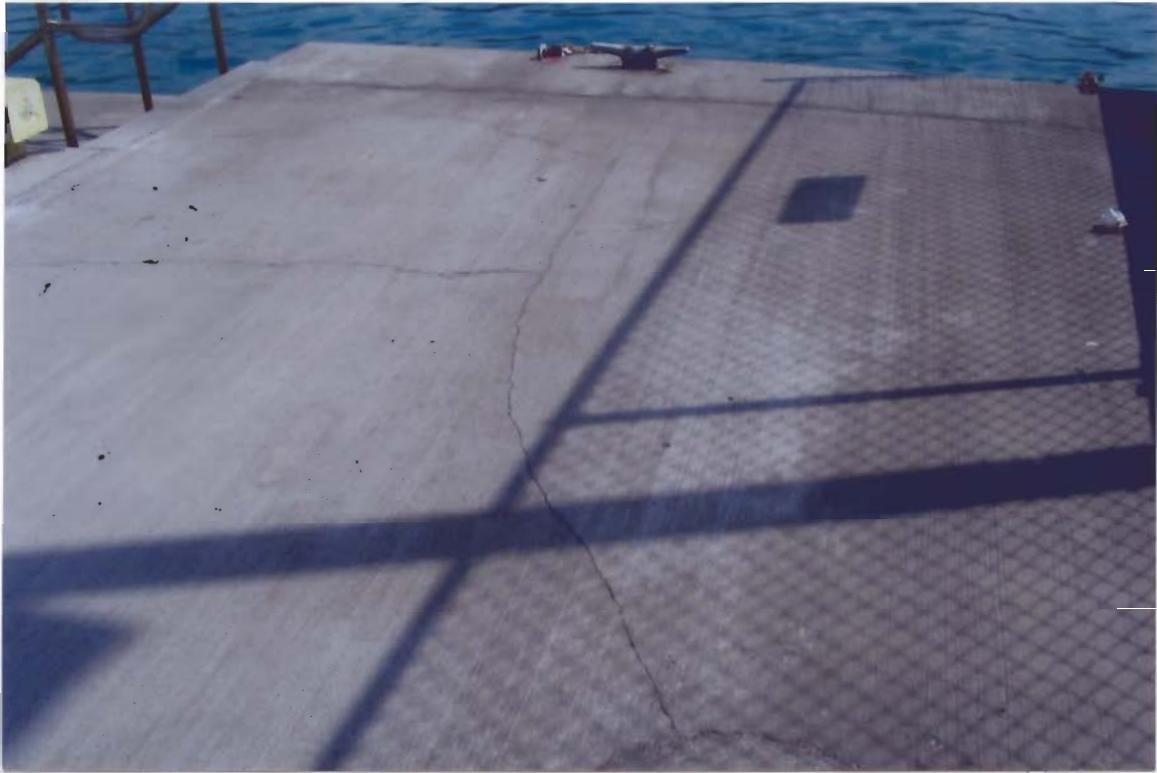
32

South End - Typical cracks at
deck slab throughout

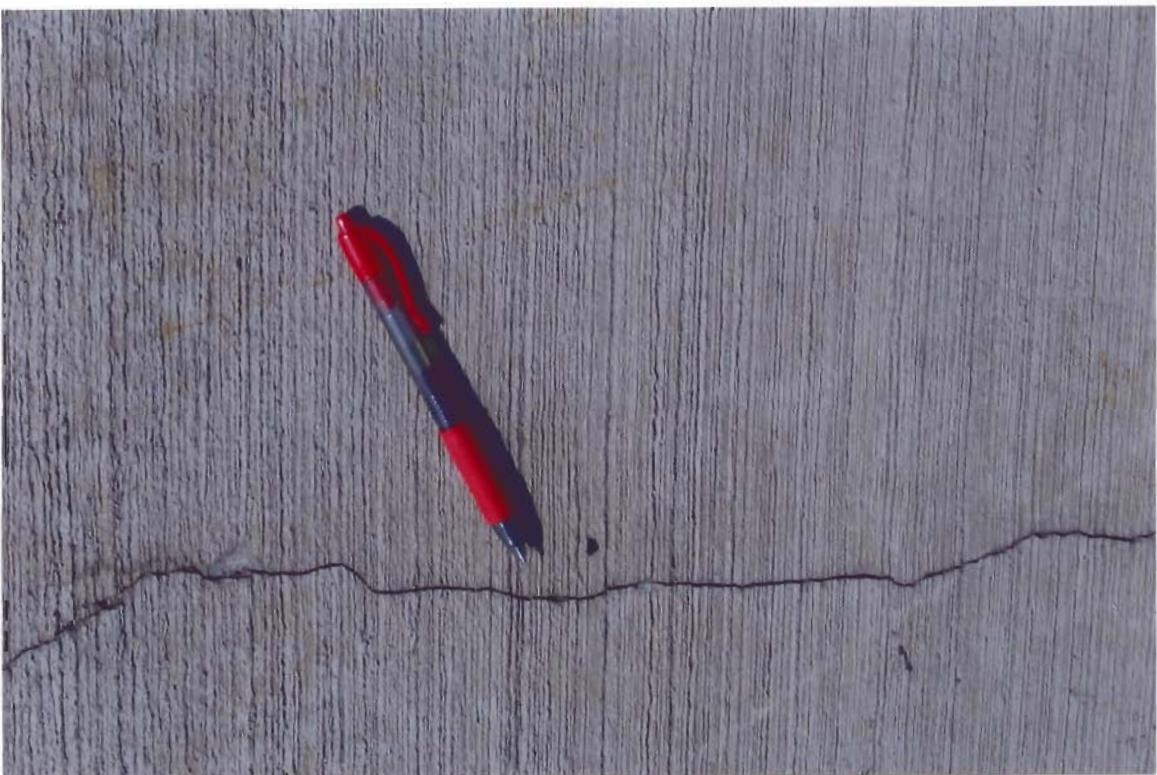
33

South End - Close-up view of typical
cracks on deck slab

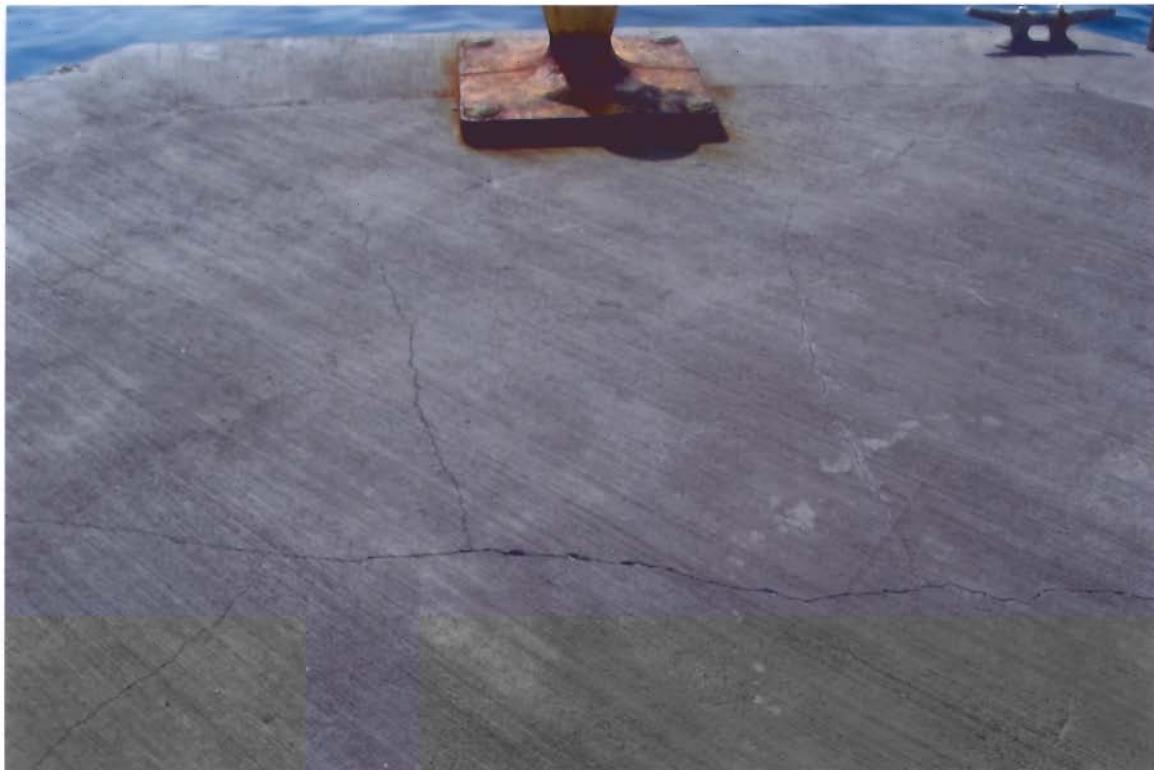
34

South End - Cracks on
deck slab throughout area
